CAA and EASA Airworthiness Directives (ADs) all owners notified.

Safety Information

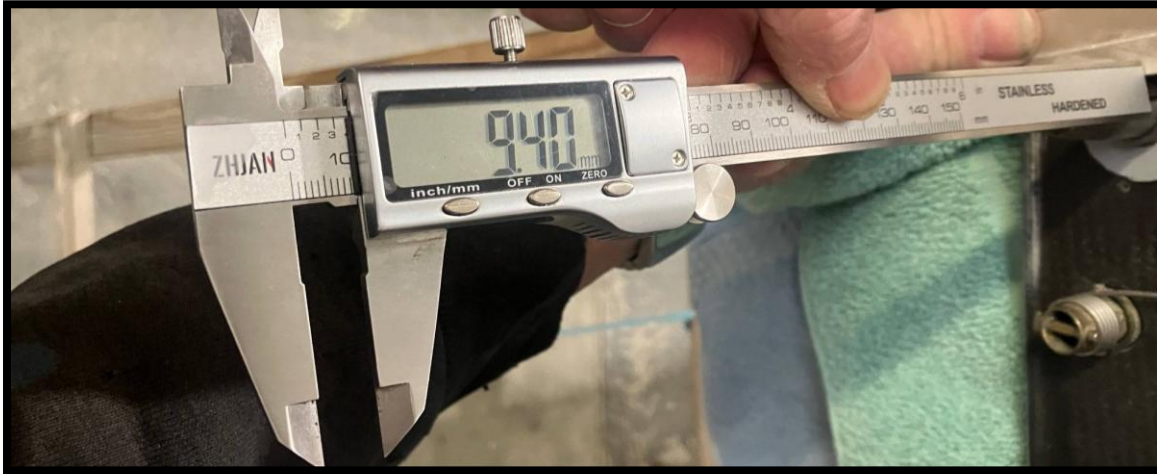
Later Schempp-Hirth gliders seem more prone to wearing the spigot at the point it sits in the fuselage bearing, often on the bottom surface. It is not too daunting to replace them provided you use some heat and a LOT of brute force!

First step is to measure in some repeatable way, the protrusion of the spigot shims.
